Corrosion Risk Assessment, and Corrosion Mitigation for Balconies Concrete Slab

June 07 2022

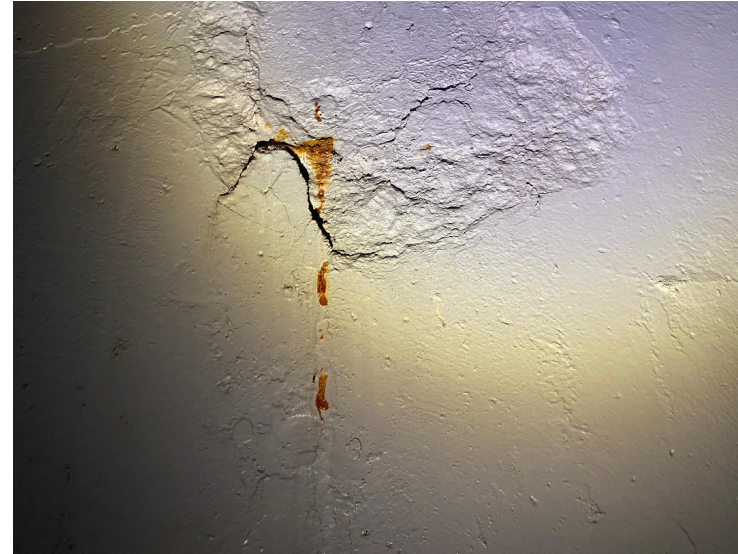
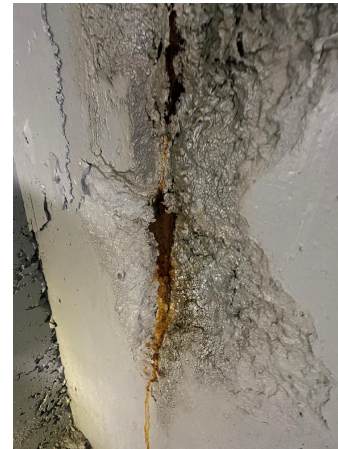
Improper paint repair resulted in hiding and further corrosion

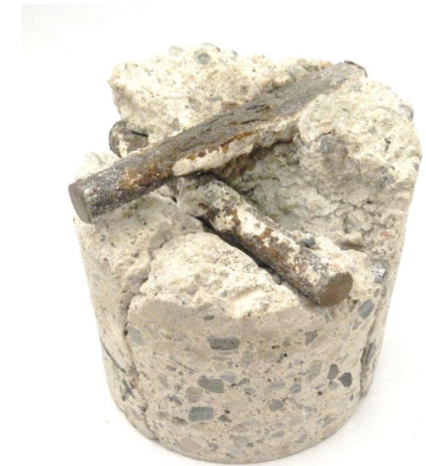
- Ingress of chlorides
- Corrosion, Loss in Thickness
- Generation of voluminous rebar corrosion products
- Spalling of concrete

Wall Street Journal : Steps in rebar corrosion, Sketch provided by Dr. Zee

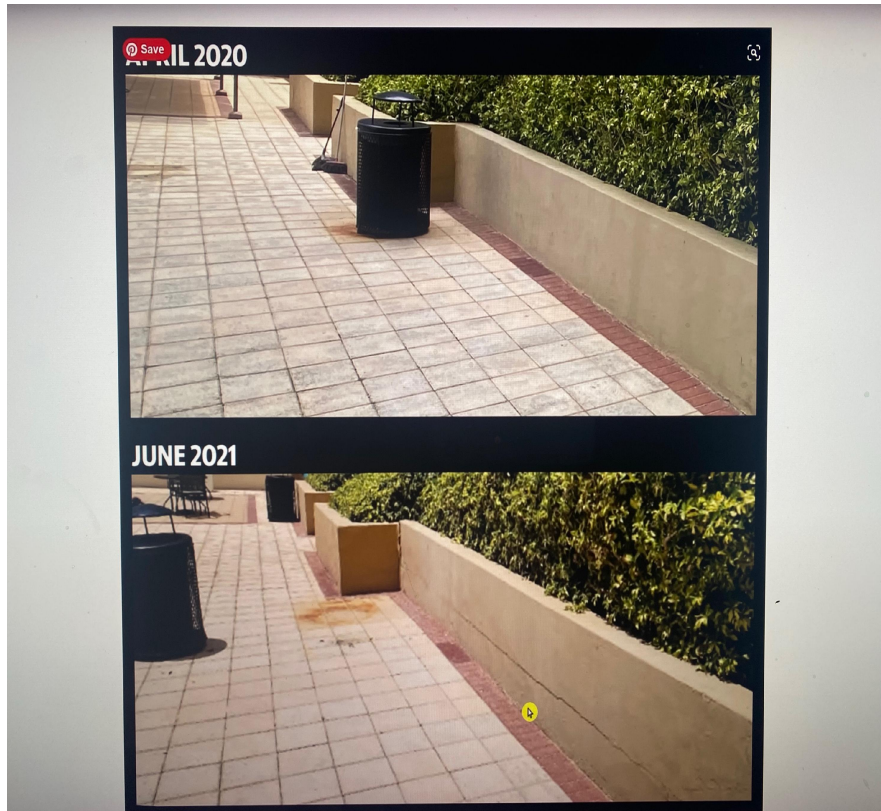
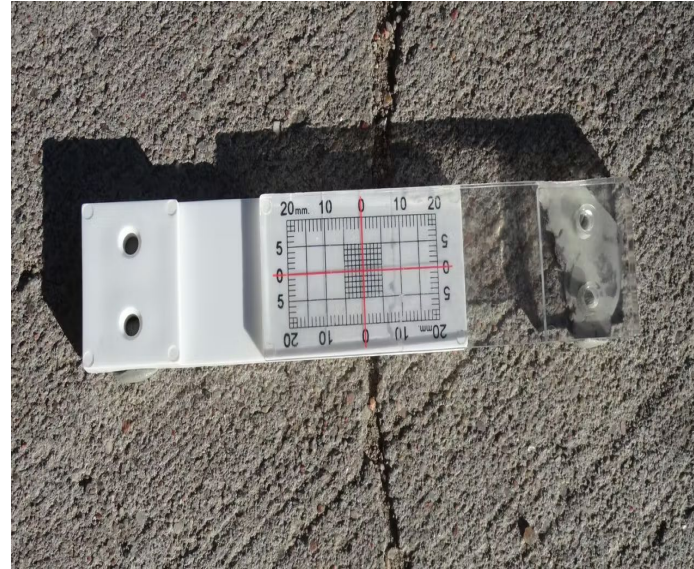
Rapid growth of surfside building crack one week prior to tragic collapse that resulted in loss of hundred souls indicated unacceptable risk is present. The inspection company did not pay attention and neglected the formation and propagation of the crack.

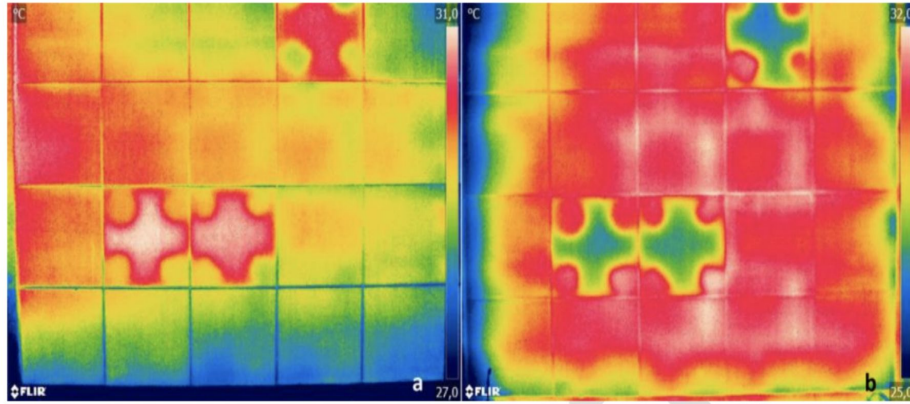
Figure 1: Thermograms from the tiles during day (left) and night (right)

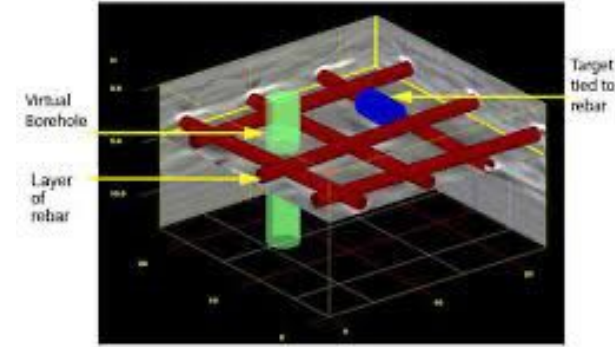
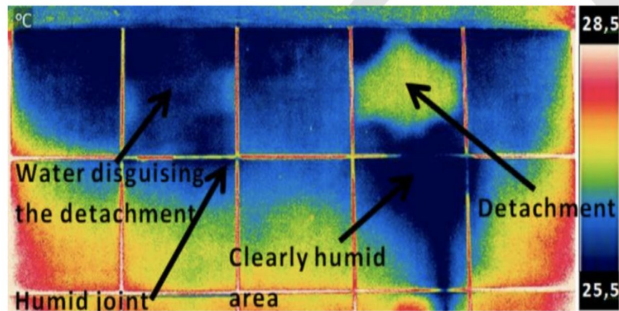
Figure 1: A thermogram and classification of anomalous tiles is shown

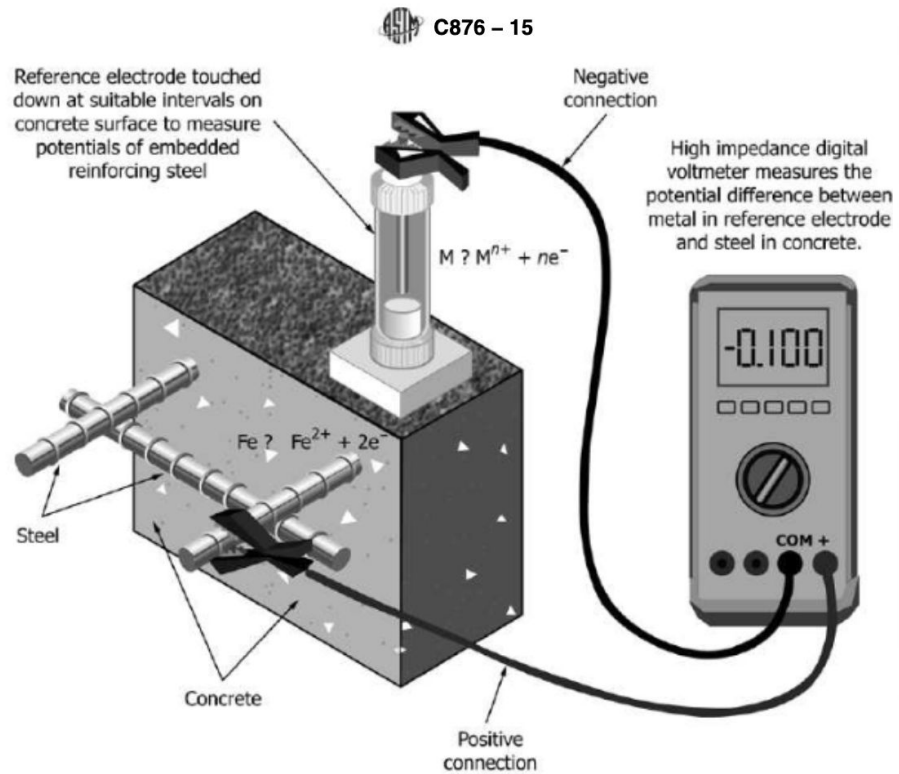
FIG. 1 Reference Electrode Circuitry

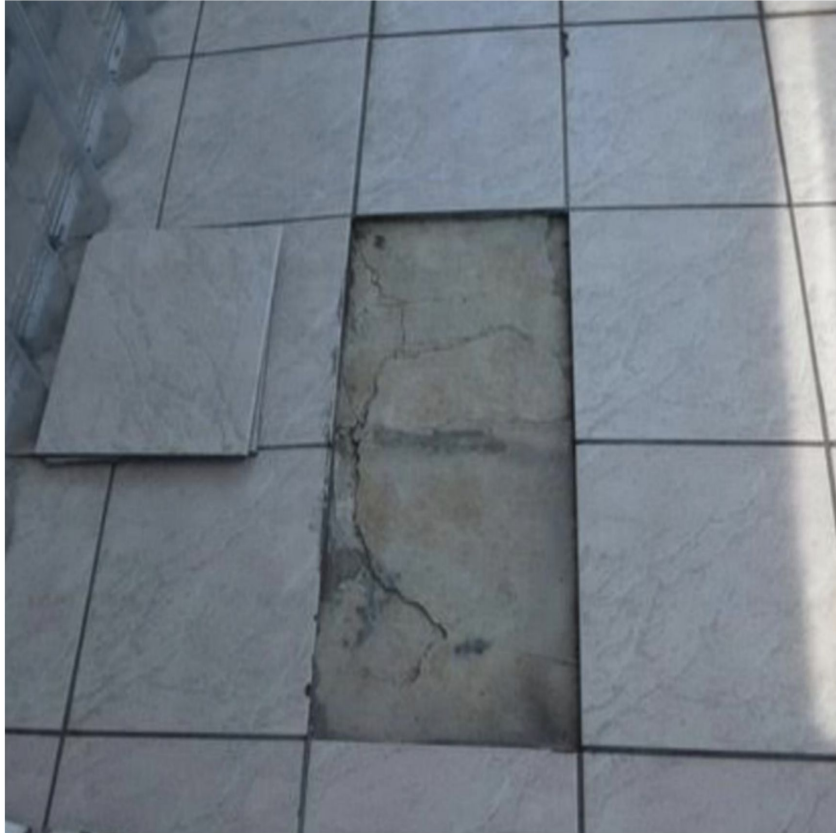
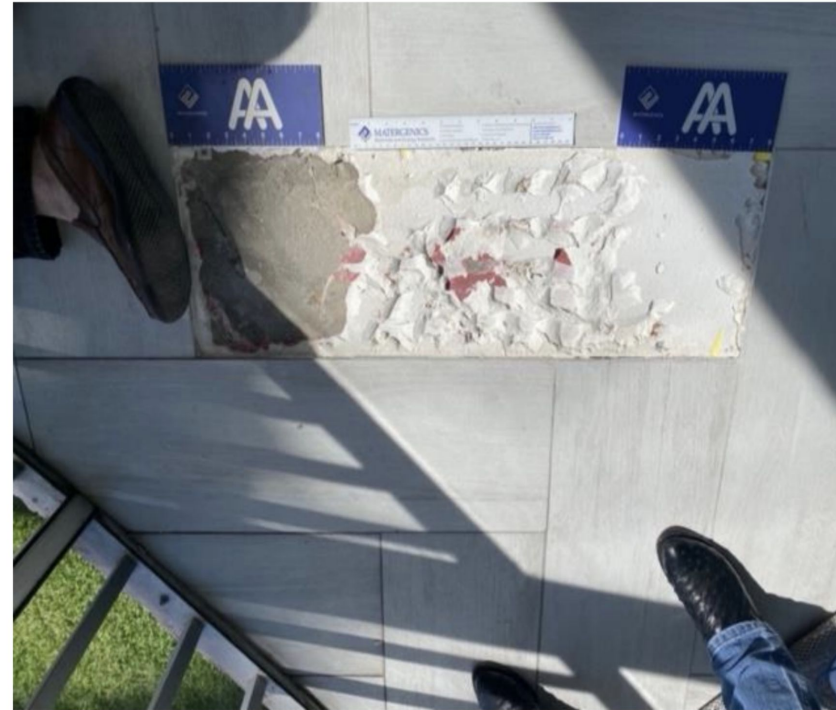
Area selected for corrosion risk assessment exhibiting mortar and water proofing coating

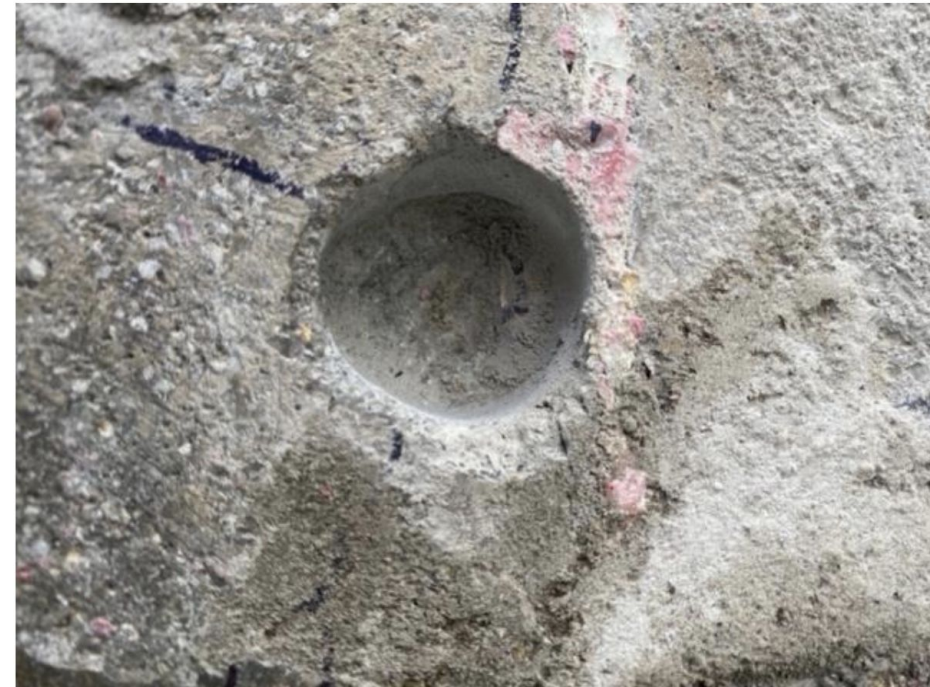
No evidence of corrosion risk at this location

Figure on the left shows phenolphthalein (Pink) , colorless in acidic environments and pink in basic solutions.

Figure on the right is a closeup on the point in which rebar is underneath and measurements were taken as close as possible and also see the formation of rust if present .

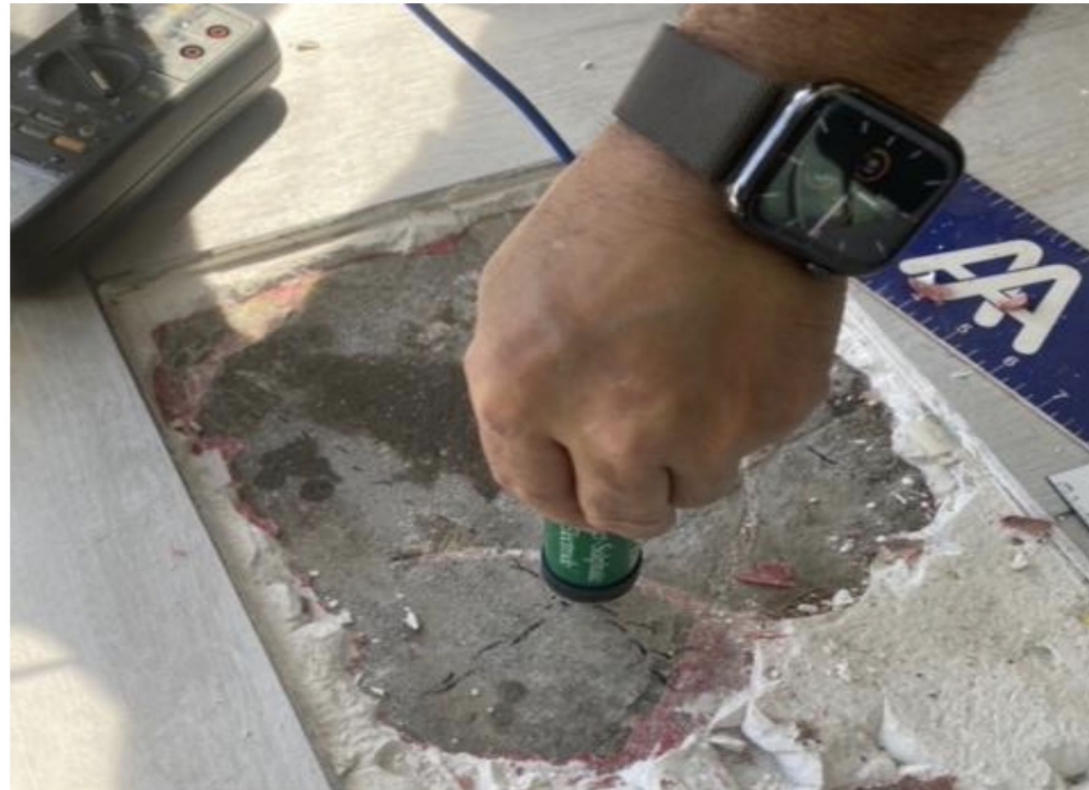
Potential Measurement on Rebar Location marked with a x.

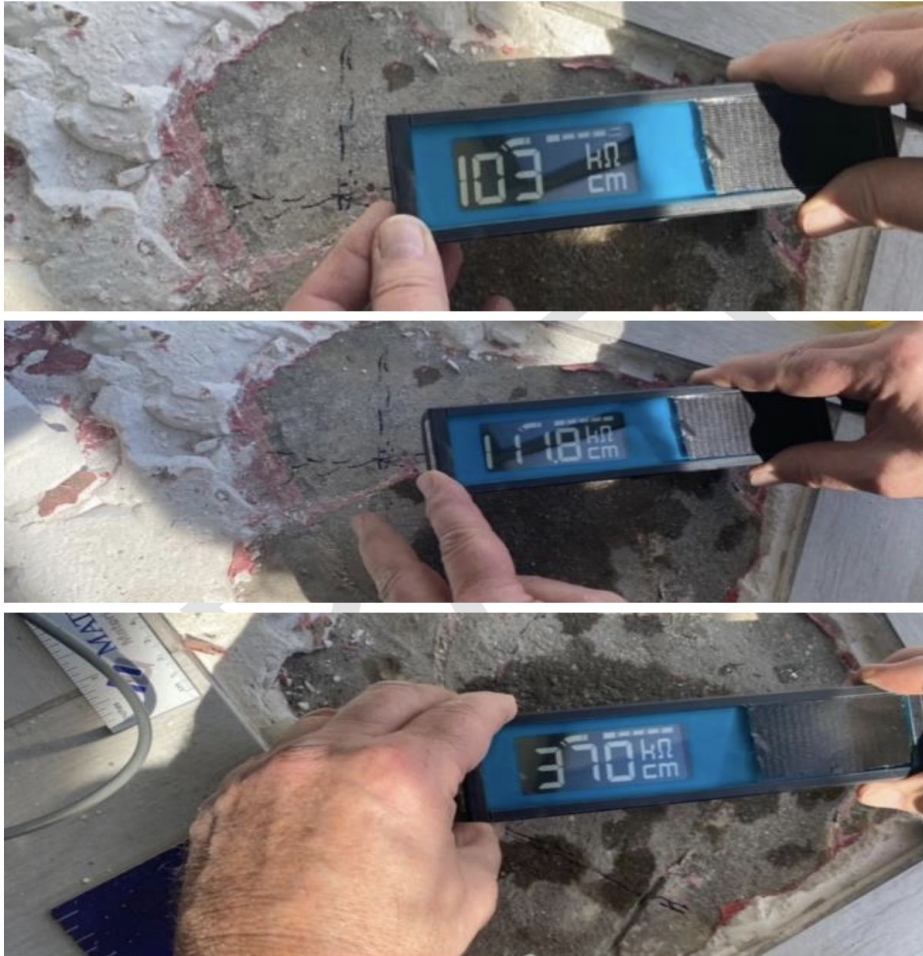
Concrete electrical resistivity measurement

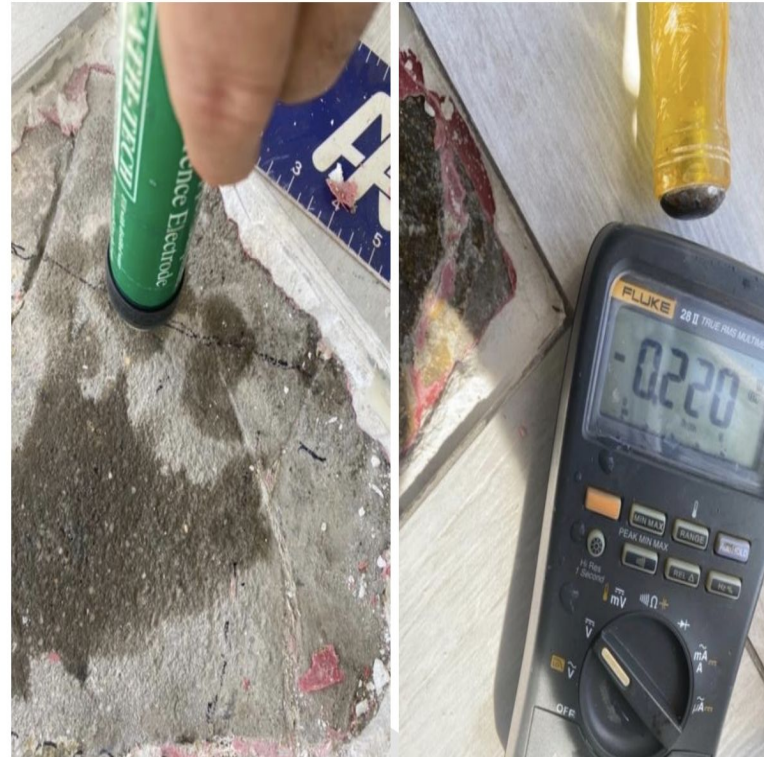
Electrochemical potential measurement
